STRUCKHOFFS DAM

ST. CHARLES COUNTY, MISSOURI

MO 30100

# PHASE 1 INSPECTION REPORT NATIONAL DAM SAFETY PROGRAM

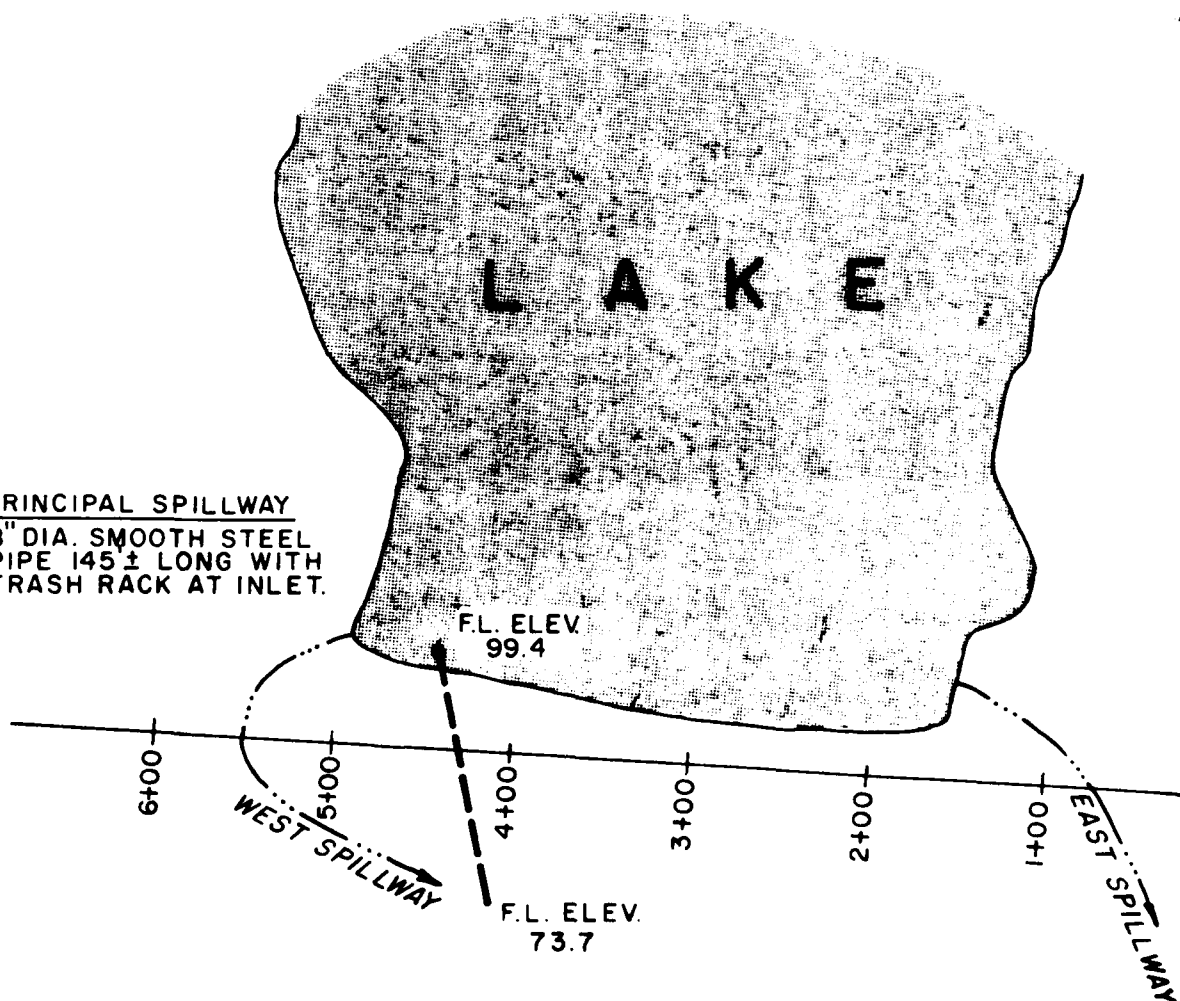
PLAN OF DAM AND SPILLWAYS

PRINCIPAL SPILLWAY  
 8" DIA. SMOOTH STEEL  
 PIPE 145'± LONG WITH  
 TRASH RACK AT INLET.
